DEPARTMENT OF TRANSPORTATION**DIVISION OF ENGINEERING SERVICES**

Contract #: 04-0120F4Cty: SF/ALA Rte: 80 PM: 13.2/13.9File #: 1.28**WELDING INSPECTION REPORT****Resident Engineer:** Casey, William**Address:** 333 Burma Road**City:** Oakland, CA 94607**Report No:** WIR-029142**Date Inspected:** 13-Feb-2013**Project Name:** SAS Superstructure**OSM Arrival Time:** 700**Prime Contractor:** American Bridge/Fluor Enterprises, a JV**OSM Departure Time:** 1730**Contractor:** American Bridge/Fluor Enterprises, a JV**Location:** Job Site**CWI Name:** As noted below**CWI Present:** Yes No**Inspected CWI report:** Yes No N/A**Rod Oven in Use:** Yes No N/A**Electrode to specification:** Yes No N/A**Weld Procedures Followed:** Yes No N/A**Qualified Welders:** Yes No N/A**Verified Joint Fit-up:** Yes No N/A**Approved Drawings:** Yes No N/A**Approved WPS:** Yes No N/A**Delayed / Cancelled:** Yes No N/A**Bridge No:** 34-0006**Component:** SAS OBG**Summary of Items Observed:**

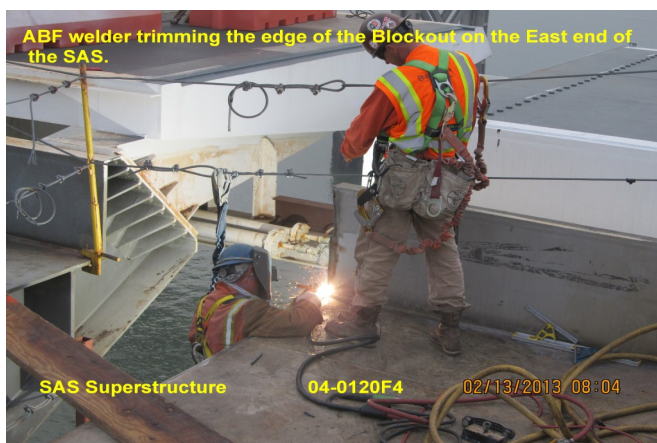
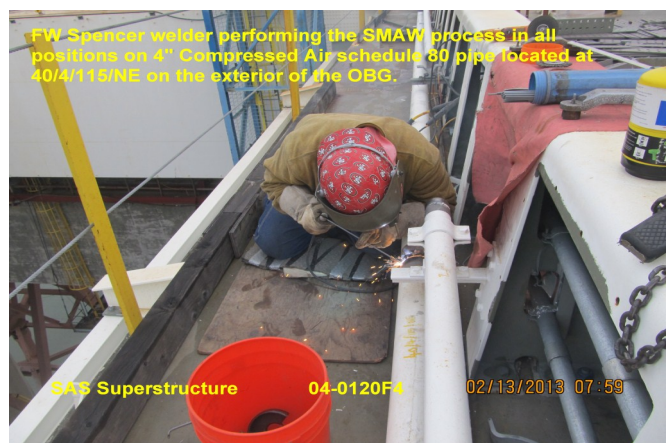
ABF welder Mike Jimenez #4716 was observed performing the ongoing SMAW on the Deck Access Hole at 14W PP126.5-W2-DAH. The welder was observed utilizing WPS ABF-D1.5-1040C-CU for SMAW. The welder was observed preheating the welds prior to welding. Other welding parameters as inspected by the QC Inspector were recorded as 136 amperes and appeared to be in compliance with the WPS noted above. The QA Inspector made subsequent observations throughout the shift to monitor quality and noted that the work was in progress and appeared to be in general conformance with the contract documents.

welder was observed utilizing WPS ABF-WPS-D15-1004-Repair-Revision 0 for SMAW. The welder was observed preheating the welds prior to Carbon Arc Gouging and welding. Other welding parameters as inspected by the QC Inspector appeared to be in compliance with the WPS noted above. This QA Inspector made subsequent observations throughout the shift to monitor quality and noted that work was completed on this date and appeared to be in general conformance with the contract documents.
